Client:
Reservoir

Location:
East Midlands

RVT's Fully Compliant Water Management System Stopped Contaminated Water Entering The River Goyt During an Extensive Restoration Project at Toddbrook Reservoir

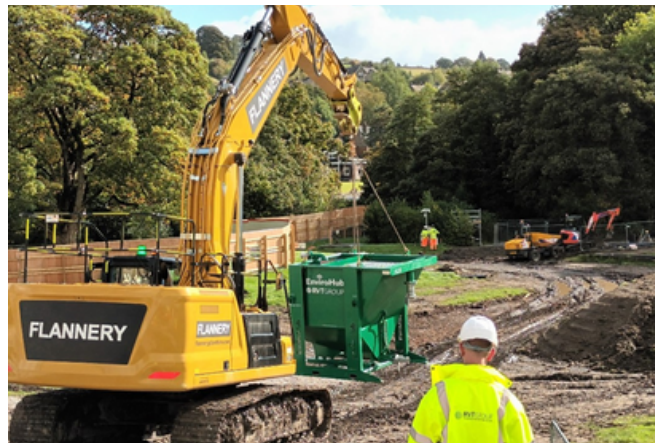
EnviroHub®
Lamella Tank

RVT promptly attended site, took and analysed water samples and combined the sample information with the geological nature of the ground. As a result, RVT proposed a complete EnviroHub® chemical dosing water management system. This included EnviroHub® TU02 Dosing Skid, EnviroHub® TT10 Treatment Tank and EnviroHub® HL50 Lamella Plate Settlement Tank. The EnviroHub® system was able to achieve a particulate removal rate of around 95%. The system accomplished this by the neutralisation of colloidal (fine/clay) particles, allowing them to agglomerate together forming heavier flocs, which then easily settle out in our EnviroHub® Lamella Tanks.

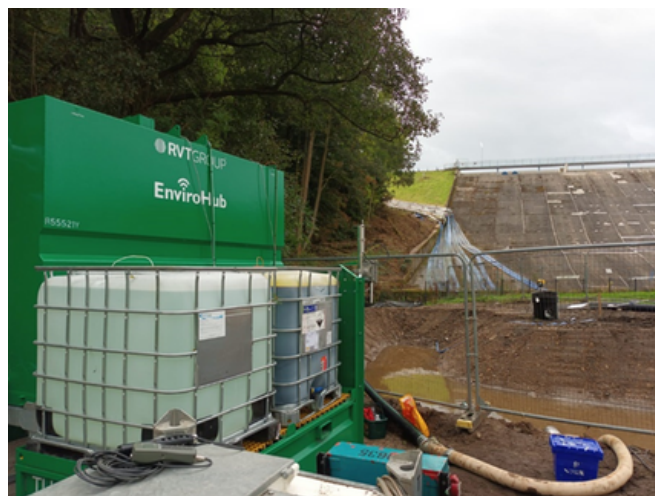
EnviroHub® Water
Management
System

Furthermore, our real-time EnviroHub® Monitoring Unit would generate automatic text and email alerts to warn the site team when the system was approaching the set compliance limits. This made the system really easy for the site team to manage and enabled the site manager to rest assured that they would always remain compliant with their environmental water discharge permit.
